ISLE OF WIGHT STEAM RAILWAY

LOCOMOTIVE NEWS

No.89

August 2017

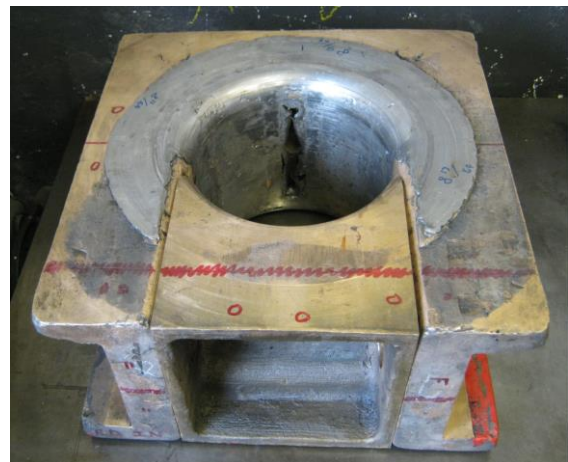
When the weather allowed, the laborious job of hand scraping eccentrics continued in the pit, ensuring each part's perfect fit. Fitting of the straps has now been completed; the next stage will be fitting the rods and checking valve settings.

Work has continued on machining the regulator parts and hand fitting; now they will need fitting to the boiler and adjustment made to the rods and stops.

With the driving wheels removed it would have been foolish not to inspect the axle bearings; any play here could affect the life of the newly refurbished eccentrics. The findings were not good, one side showing signs of overheating, the other side with cracked and missing white metal. Both sides will also require new axle pads despite having been replaced in 2013; the 02 suffers from water overflowing the tanks as well as outside storage.

The findings on the driving wheelset will now require the leading set to be dropped and checked.

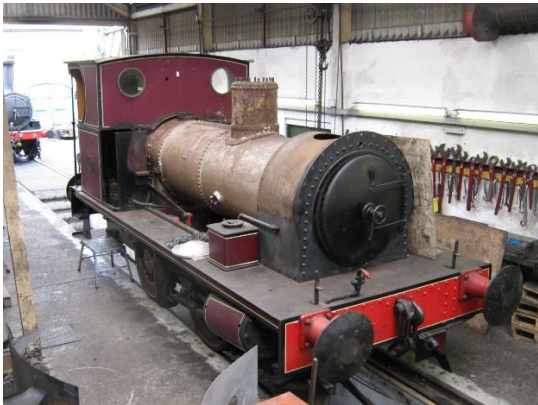
Workshop planning indicated that W24 would be requiring the wheel drop; the opportunity was taken prior to this on a Saturday in May to remove the water tank.

Once returned to the works progress has been made on removing the cladding and lagging to allow cleaning and inspection of the outside of the barrel.

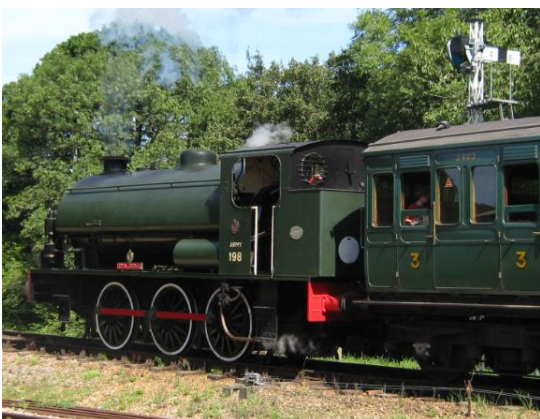
Following two consecutive days steaming to ease the locomotive back in to traffic, Tuesday 4 July saw 198 hauling its first test train over the full line. Rectification work and steaming the following day

allowed 198 to enter revenue earning service on Thursday 6th, being withdrawn at lunchtime with a sagging grate; this was made up with an assortment of old bars from 198 and 192 "you win some and lose some" to save money.

With new fire bars fitted the locomotive returned to service to meet our train service commitments over our peak season. Now having completed its first washout period with few faults, it is almost like she had never been out of service.

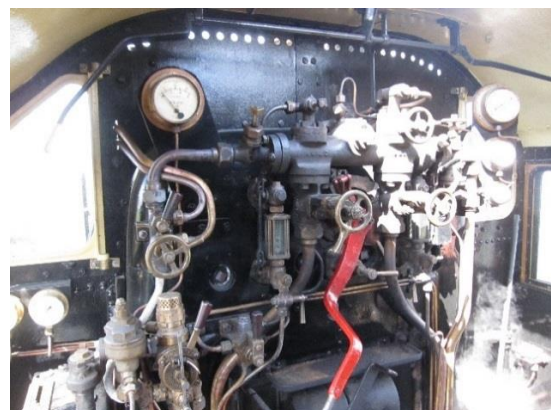
Now the restoration of 41313 has been completed the locomotive is undergoing running in at ESR. It is hoped to be returning to the Island late September / early October. Once here work to complete and test the Westinghouse system will be progressed. Currently ESR are using the vacuum brakes.

Next year will give crews the opportunity to compare two locomotives of the same class, remember the saying "no two engines are alike", even the cab is airier with lack of AWS.

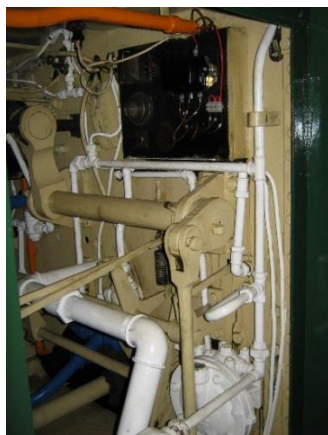
D2554 'Fred'

Work has continued on the air system, tracing air leaks; this has involved temporary blanking of sections to identify the eventual cause. The electrical side of the locomotive is still receiving attention when labour allows.

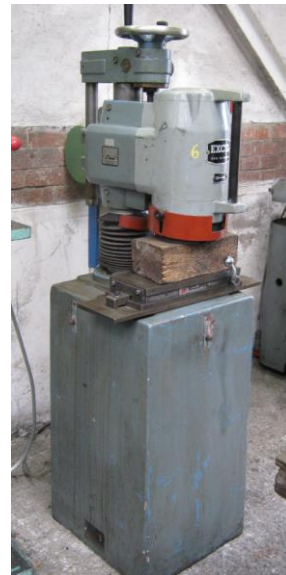
Most recently removed from storage is an Excel plough grinder (ex- Westland Aerospace) to further enhance our machining capabilities. Also seeing some attention are the small set of rolls used for bending thin sheet.
